Report No.: G100269149GRR-001B

Test Report For:

Summit Technology Corporation

Mechanical Shock

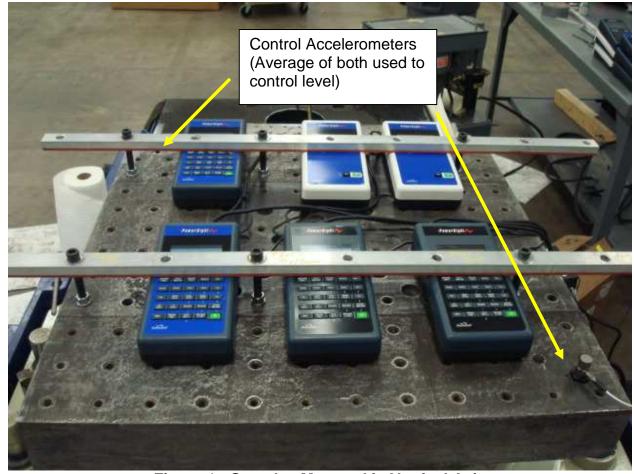
Figure 1: Samples Mounted in Vertical Axis

The meter orientation and accelerometer placements for each axis are shown in Figure 1 through Figure 3.

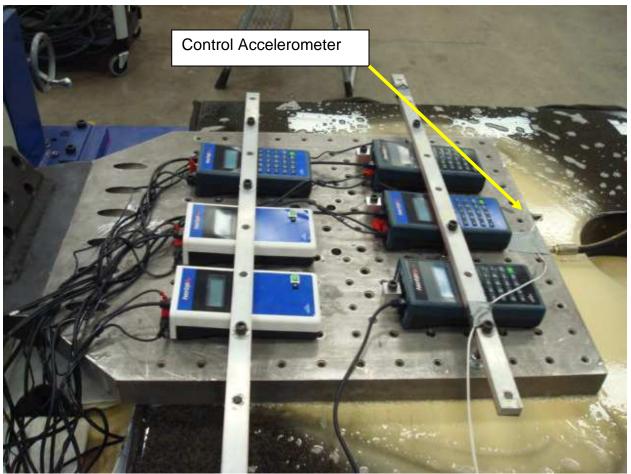
Figure 2: Samples Mounted in Longitudinal Axis

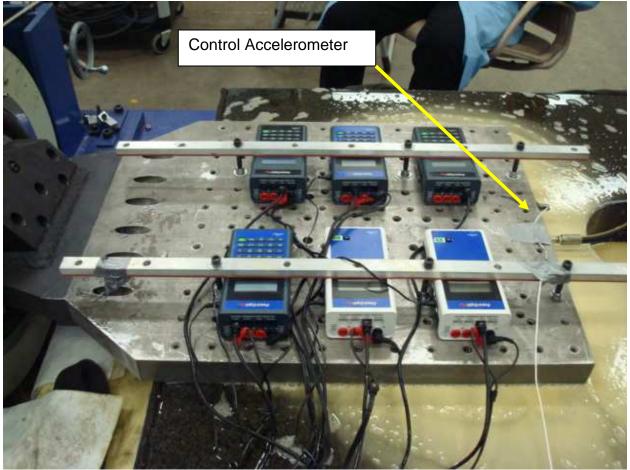
Figure 3: Samples Mounted in Lateral Axis

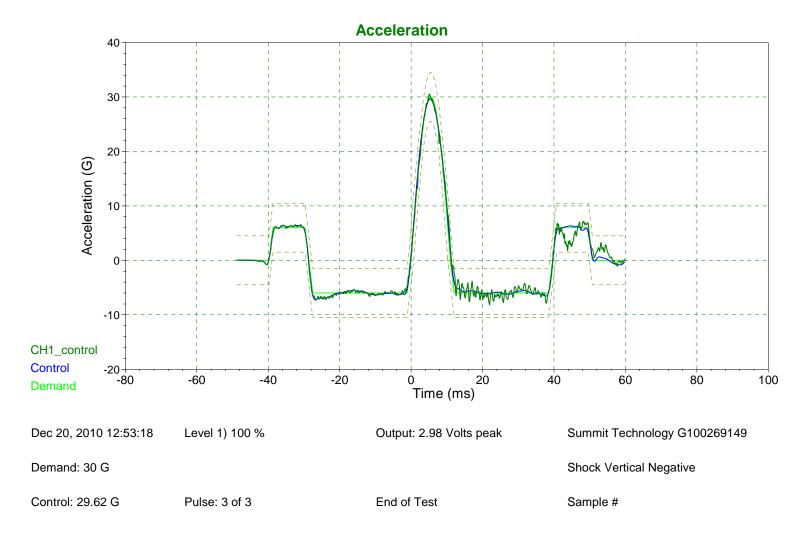
Figure 4: Positive Vertical Axis Shock Profile

Mechanical shock plots including test levels are shown in Figure 4 through Figure 9.

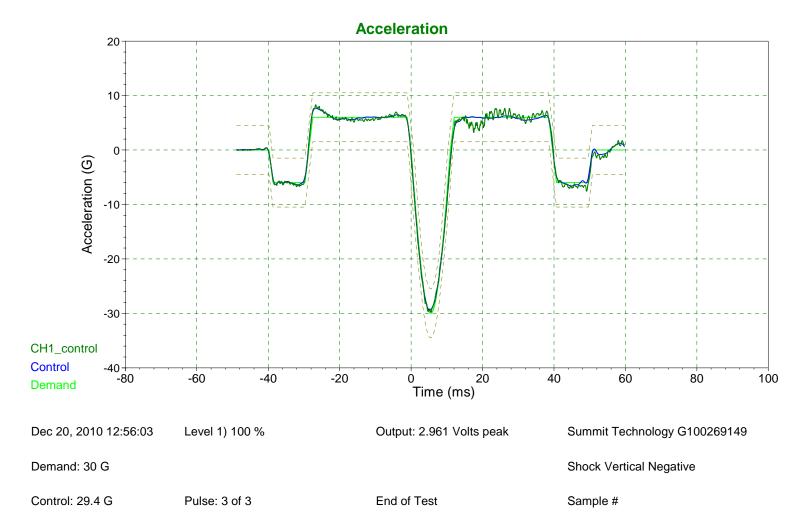
Figure 5: Negative Vertical Axis Shock Profile

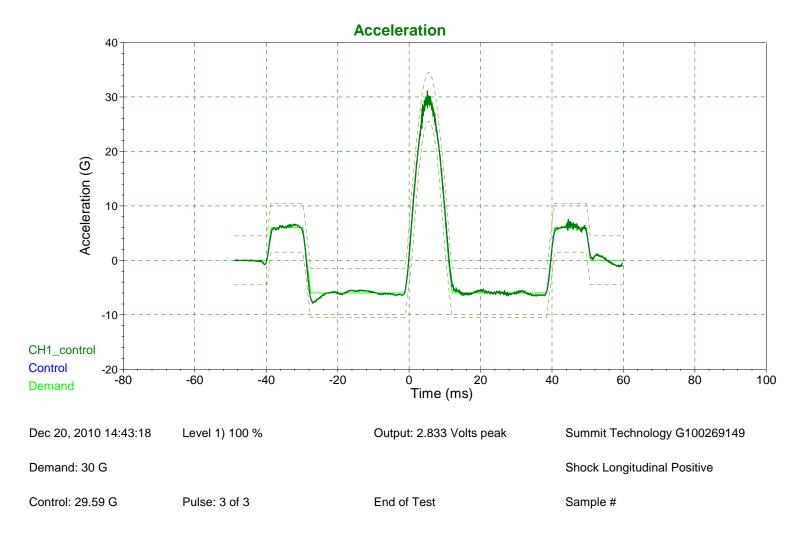
Figure 6: Positive Longitudinal Axis Shock Profile

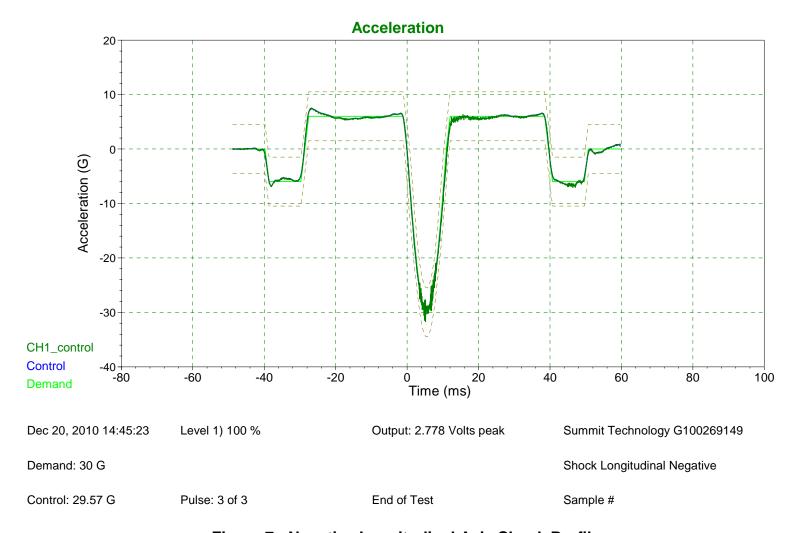
Figure 7: Negative Longitudinal Axis Shock Profile

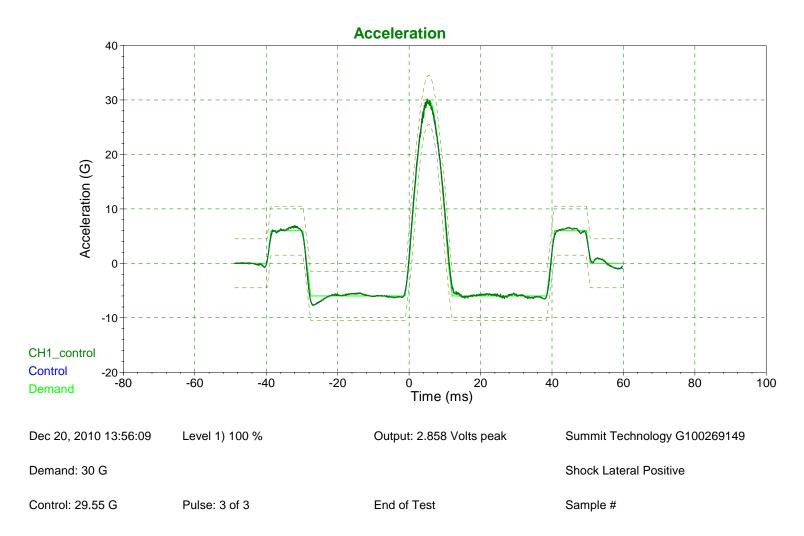
Figure 8: Positive Lateral Axis Shock Profile
